# Remedial Action Plan

## Former Delbert-Smith Greenhouses

12777 Mogadore Avenue NW  
Uniontown, Ohio 44685

PANDEY Environmental, LLC  
4100 Horizons Drive, Suite 205  
Columbus, Ohio 43220  
Phone: 614-444-8078  
[www.pandeyenvironmental.com](http://www.pandeyenvironmental.com)

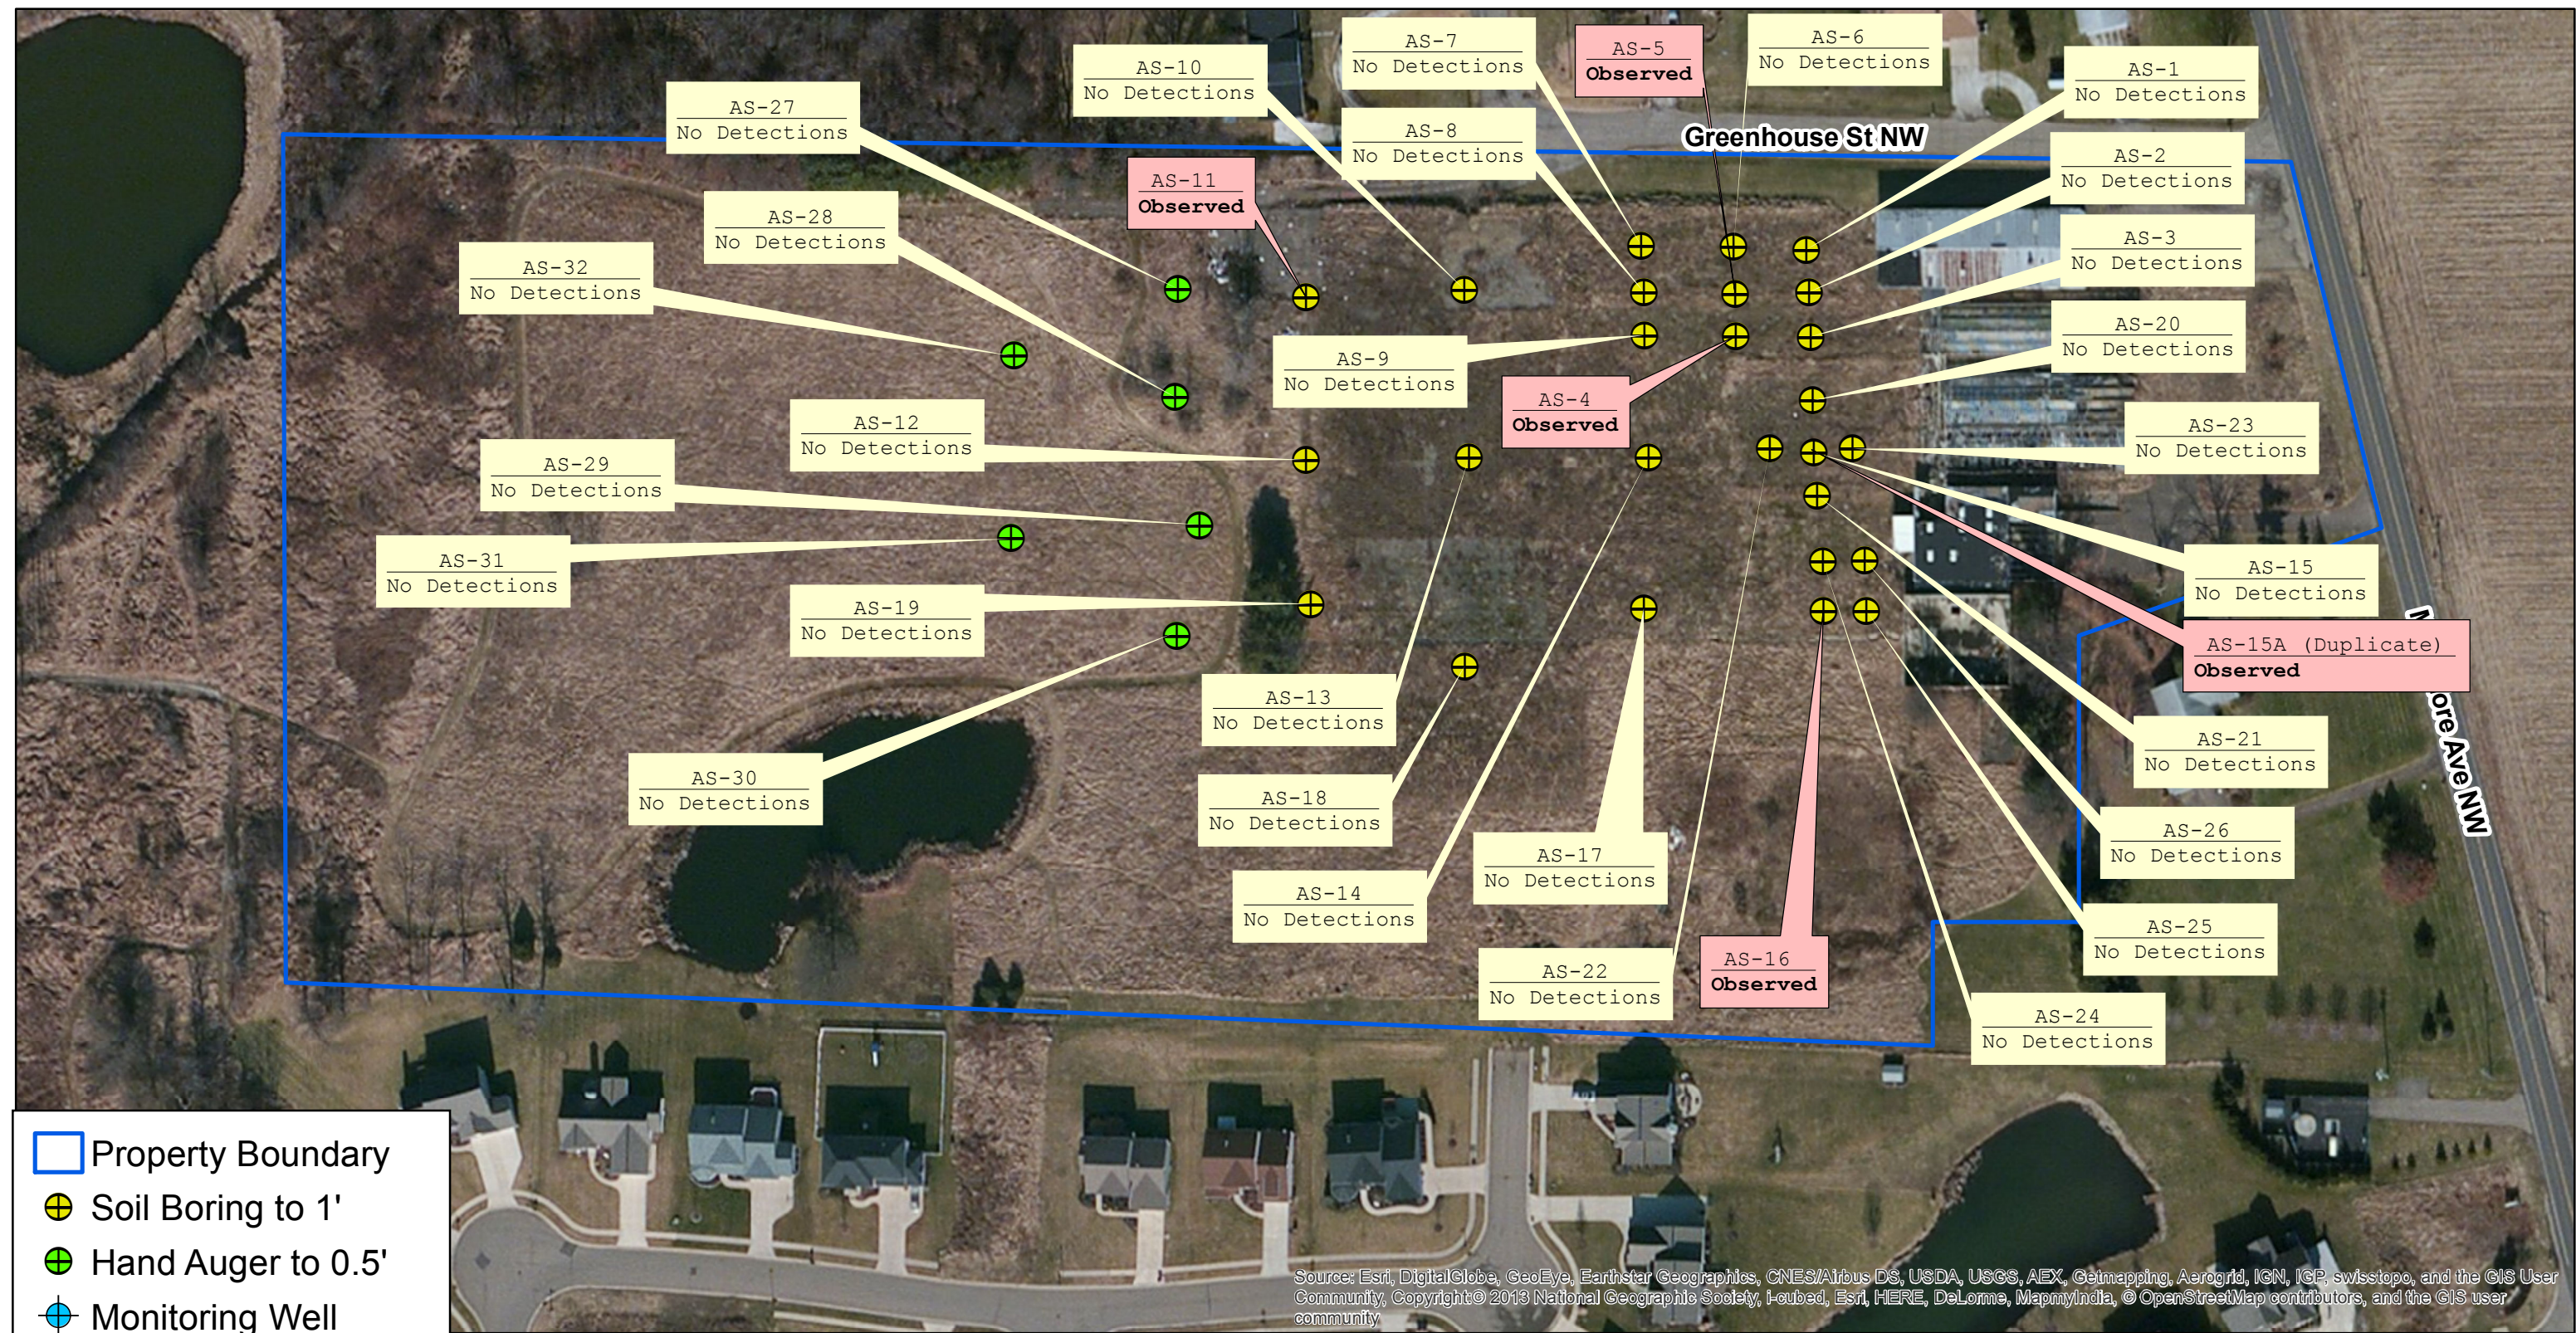
**Figure 2**  
**Comprehensive Data**  
**Figure - Asbestos Detections**

- Property Boundary
- ⊕ Soil Boring to 1'
- ⊕ Hand Auger to 0.5'
- ⊕ Monitoring Well
- ⊙ Ambient Air
- ⊙ Soil Gas Probe
- ⊕ Soil Boring to 10'
- ⊕ Existing Well On-Site
- ⬢ Sediment
- ⬢ Surface Water

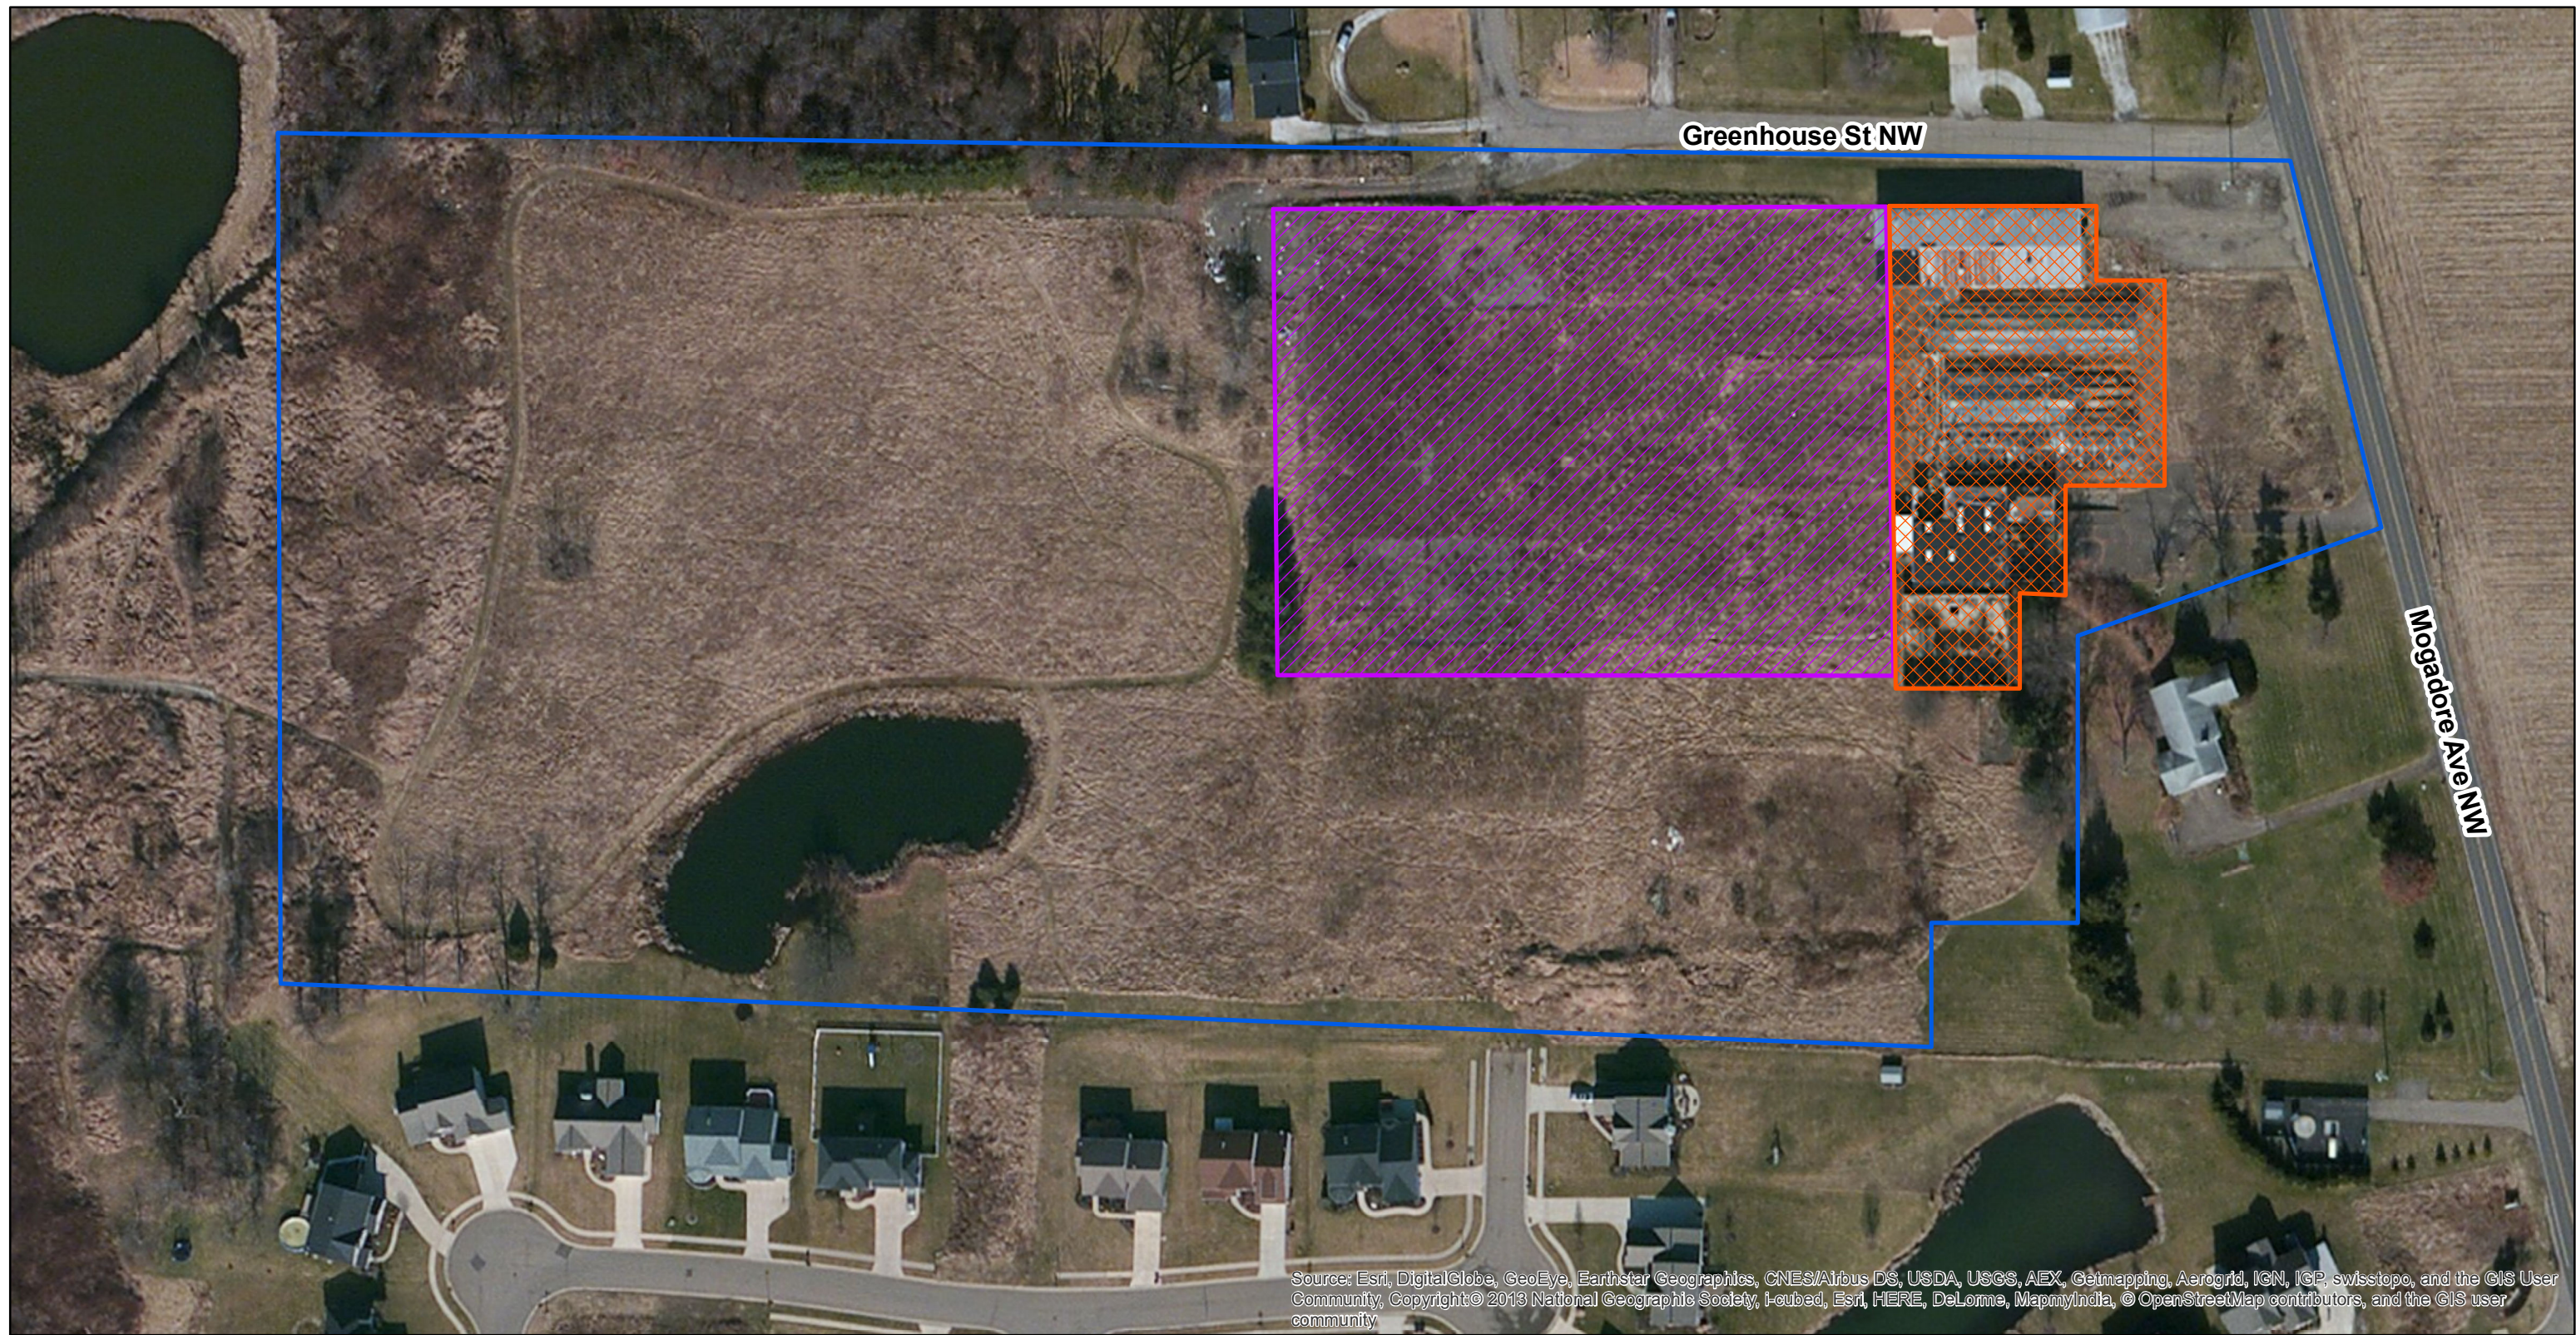
Remedial Excavation Area

The property currently has approximately six (6) standing structures which are in poor condition. Multiple areas of all structures on the property were sampled by a Certified Asbestos Hazard Evaluation Specialist (CAHES) and determined to contain Regulated Asbestos Containing Materials (RACM). The RACM from the standing structures on the subject property will be lawfully abated. Immediately following the abatement of RACM in the standing structures on the property, the buildings and greenhouses on the site can be demolished. The proposed demolition area can be found on Remediation Area Map included as Figure 3 of this Report.

The entire zero (0) to six (6) inch horizon of soil located between the on-site greenhouses and the tree line located near the center of the site will be excavated and removed to an off-site landfill, in order to remedy the contamination. The proposed excavation area can be found on the Remediation Area Map included as Figure 3 of this report.

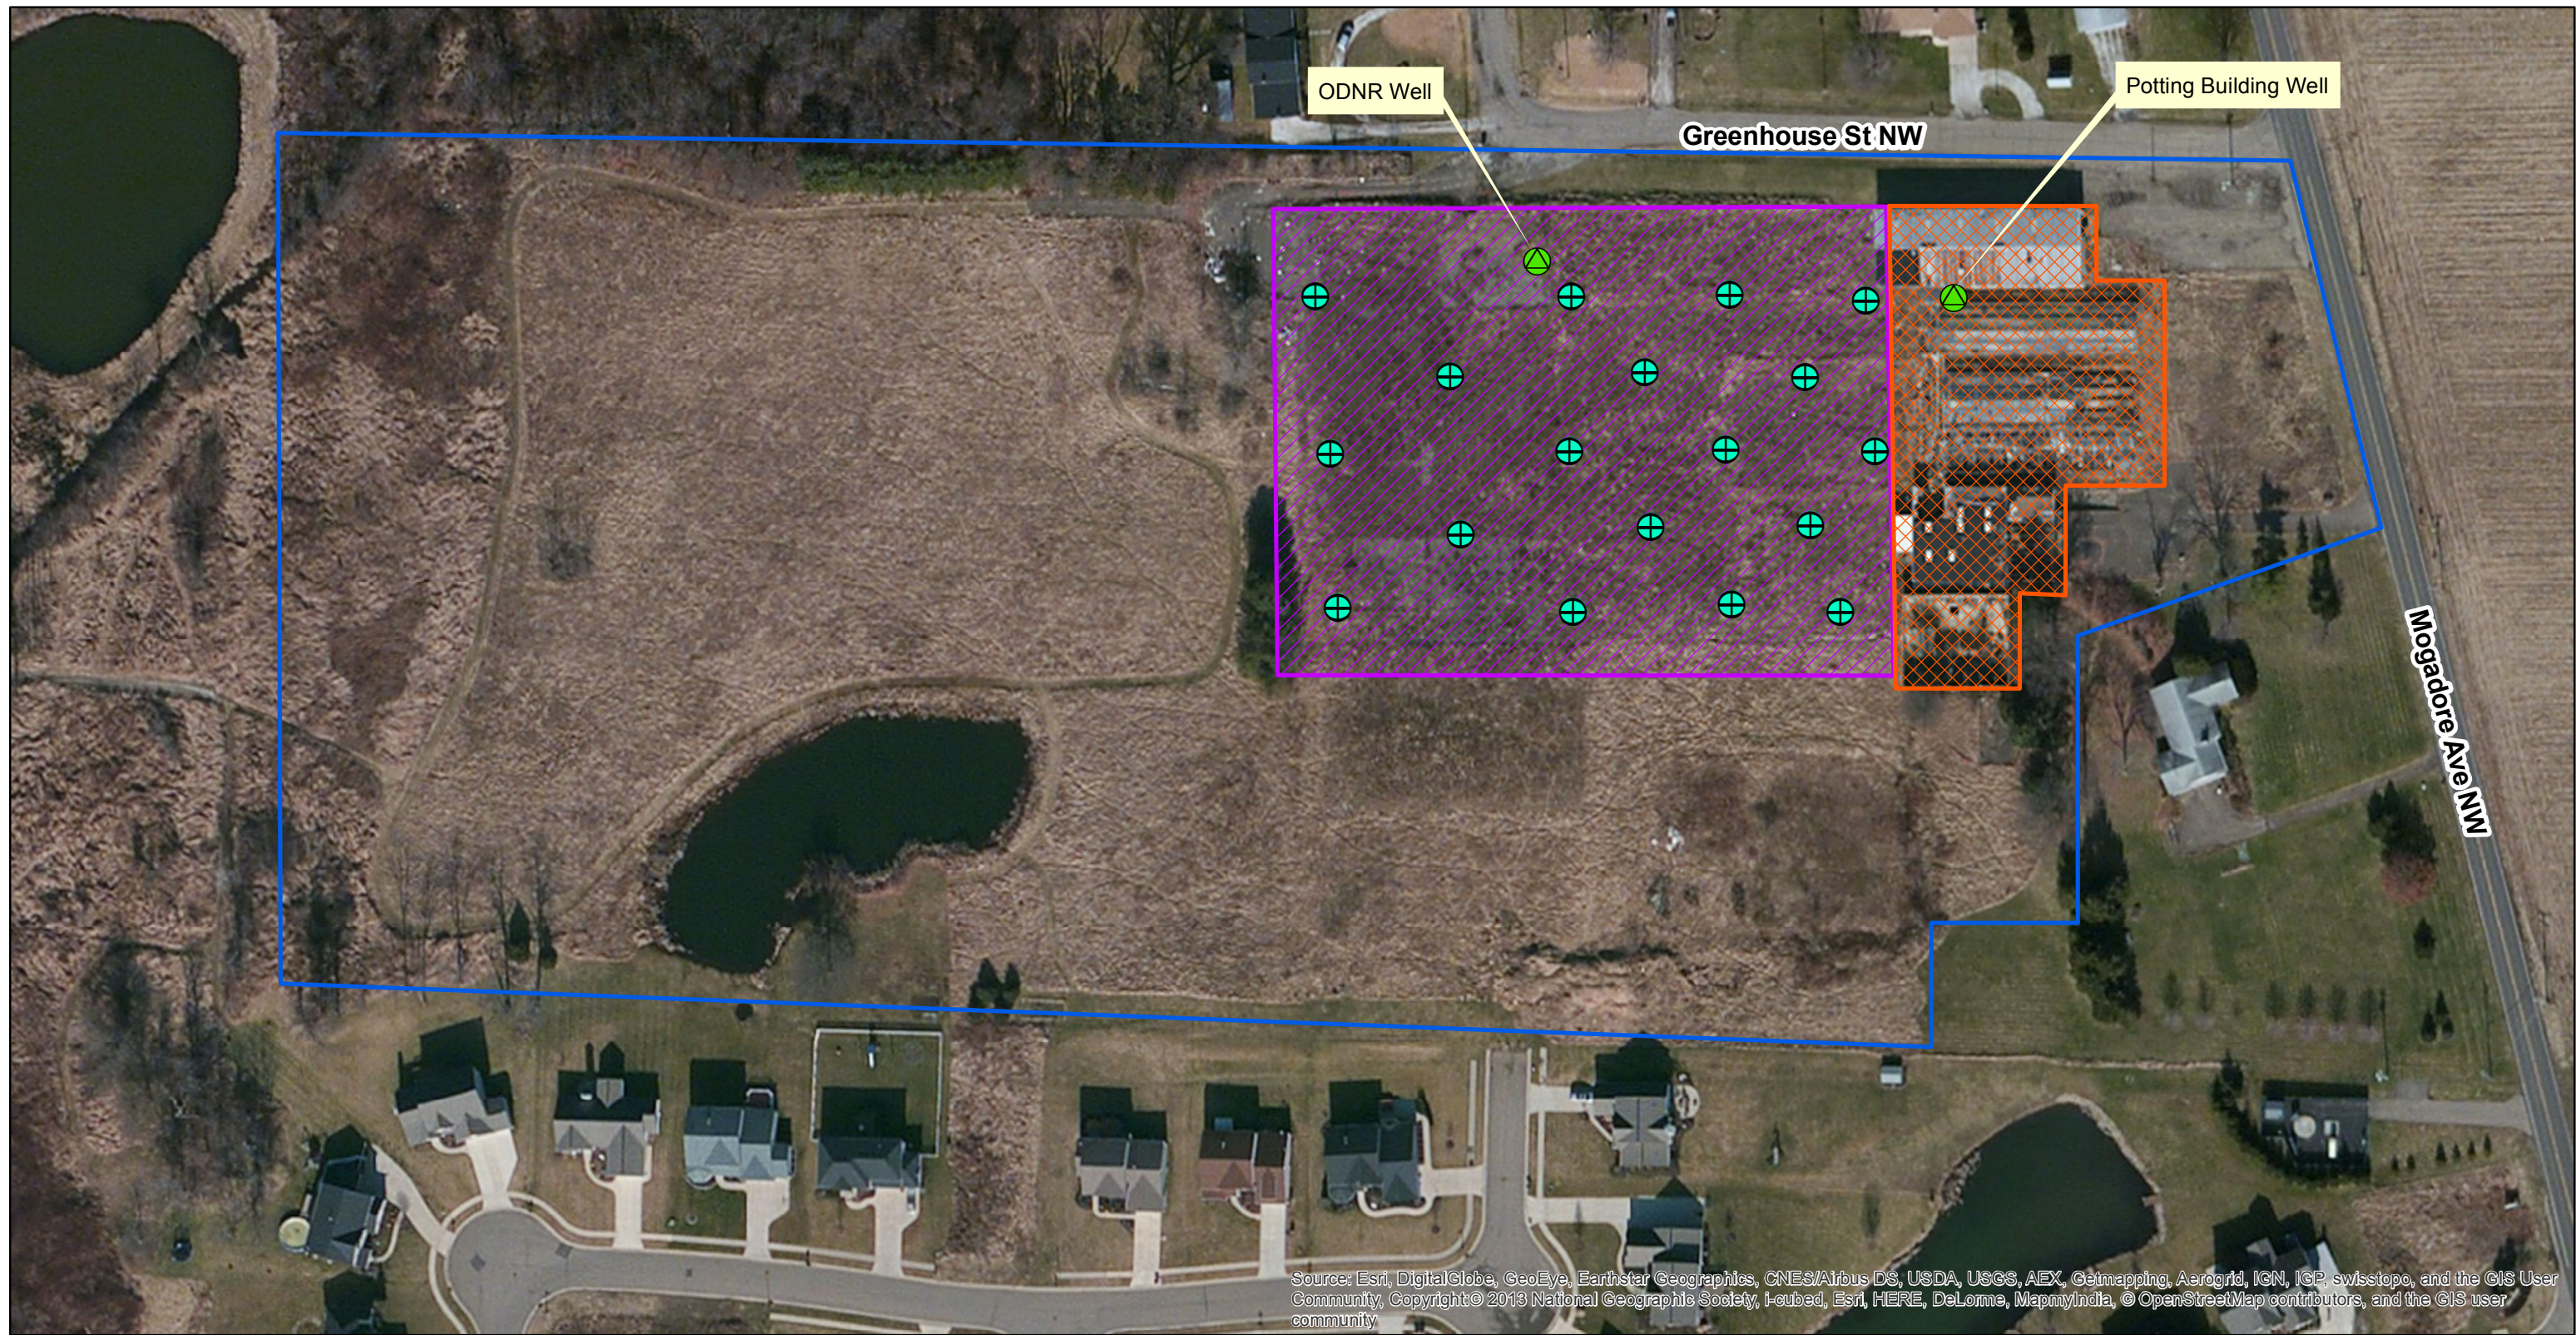
**Figure 4**  
**Confirmatory Sample**  
**Locations Map**

- Property Boundary
- Demolition Area
- Remedial Excavation Area
- ⊕ Soil Boring to 1'
- ⊕ Confirmatory Sample
- Existing Well On-Site

Results will be compared to the VAP Generic Direct Contact Soil Standards (GDCSS) for unrestricted -residential land use. The applicable VAP standard considers any detection of asbestos fibers in soil as contamination. Locations of samples are shown on the Confirmatory Sample Location Map included as Figure 4 of this report. In the event that confirmatory samples fail GDCSS regulatory limits for unrestricted land use /asbestos fibers are detected in the soils, the area the sample was collected from will be excavated an additional 6 inches and another confirmatory sample will then be collected from the base of that area for laboratory analysis.

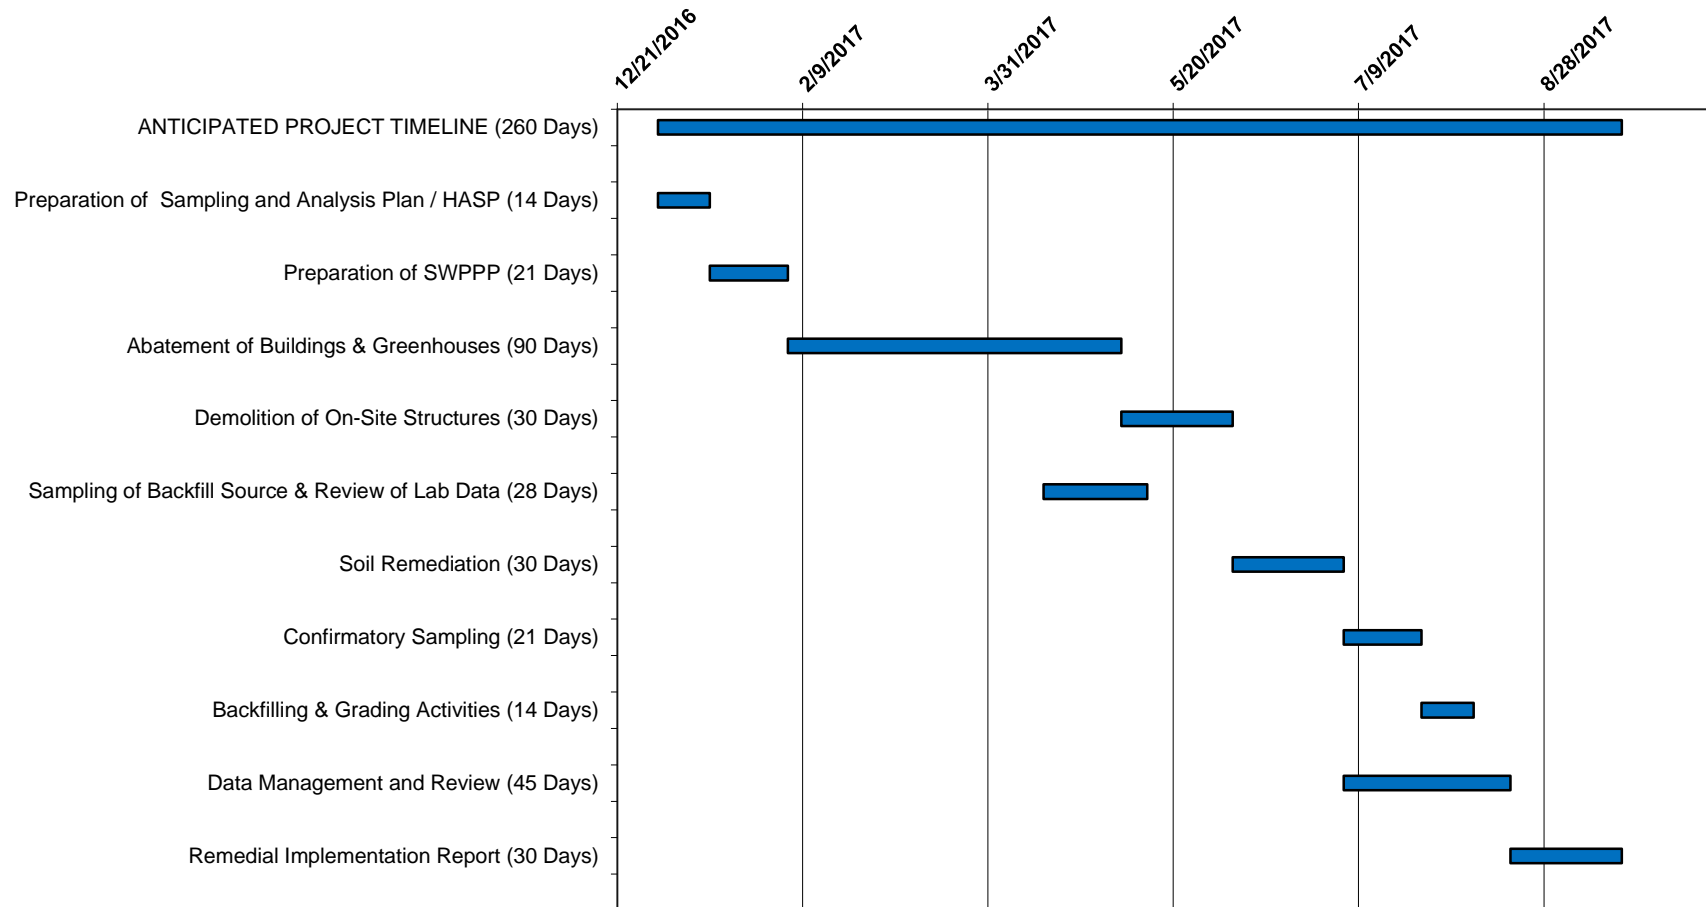
# **Project Implementation Schedule for the Remedial Action Plan/Preparation of Remedial Implementation Report Former Delbert-Smith Greenhouse Property, Uniontown, Ohio**

\*This schedule generically assumes a start date of 1/01/2017

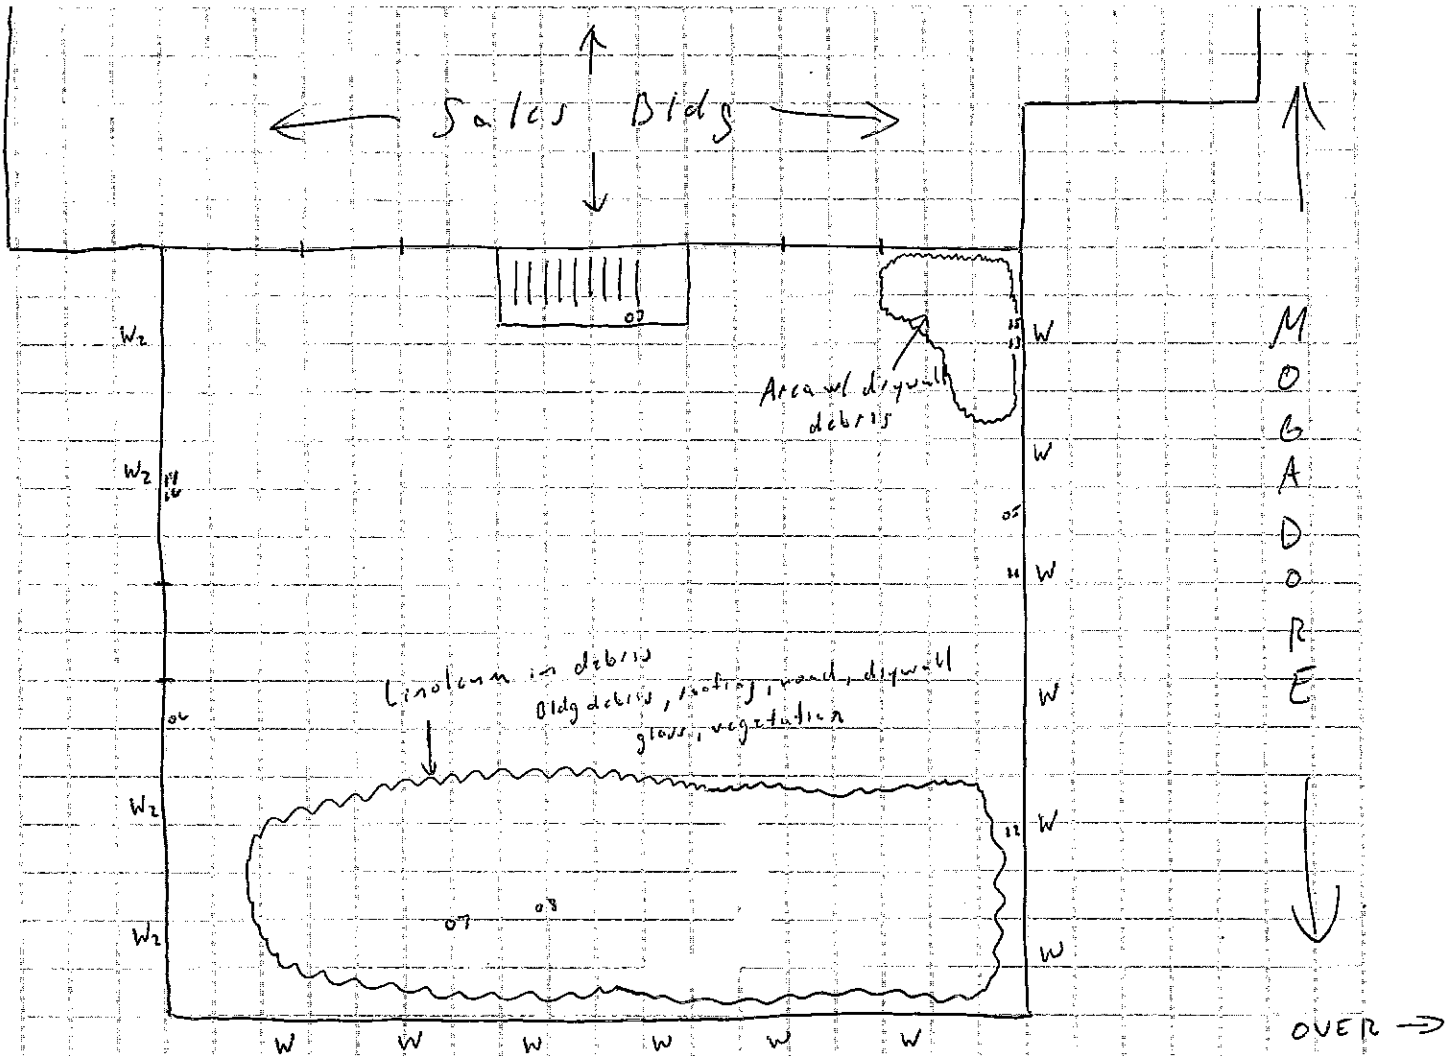
<b>EA GROUP</b>	Work Order: OH40021
	Date: 6/1/16
Title: Office Bldg, Upper	Project: Bishopgate
	Prepared By: Kowall

No roof on Office Bldg, but roofing debris observed w/in & around bldg on the ground. It is unknown if roofing debris is from Office Bldg or from adjacent Sales Bldg which has portions of roof missing and is damaged.

EA Group's licensed Asbestos Hazard Evaluation Specialist Mike Kovell, ES34424, inspected the structures and surrounding areas and developed a sampling strategy, with bulk samples of suspect ACM procured on June 1, 2016. Homogeneous Groups of suspect ACM are identified on the *Asbestos Inspection Data Sheet* forms in Appendix A. Classification of the positively identified ACM has been made per National Emission Standard for Hazardous Air Pollutants (NESHAP) regulations, with notations for compliance with Occupational Safety and Health Administration (OSHA) regulations where applicable. Room/area designations and sampling locations for the survey are provided on the attached field drawings in Appendix A.
